## OFFICE OF THE DISTRICT ATTORNEY

Re: Jeremiah Hartzel, APD case 19-3545

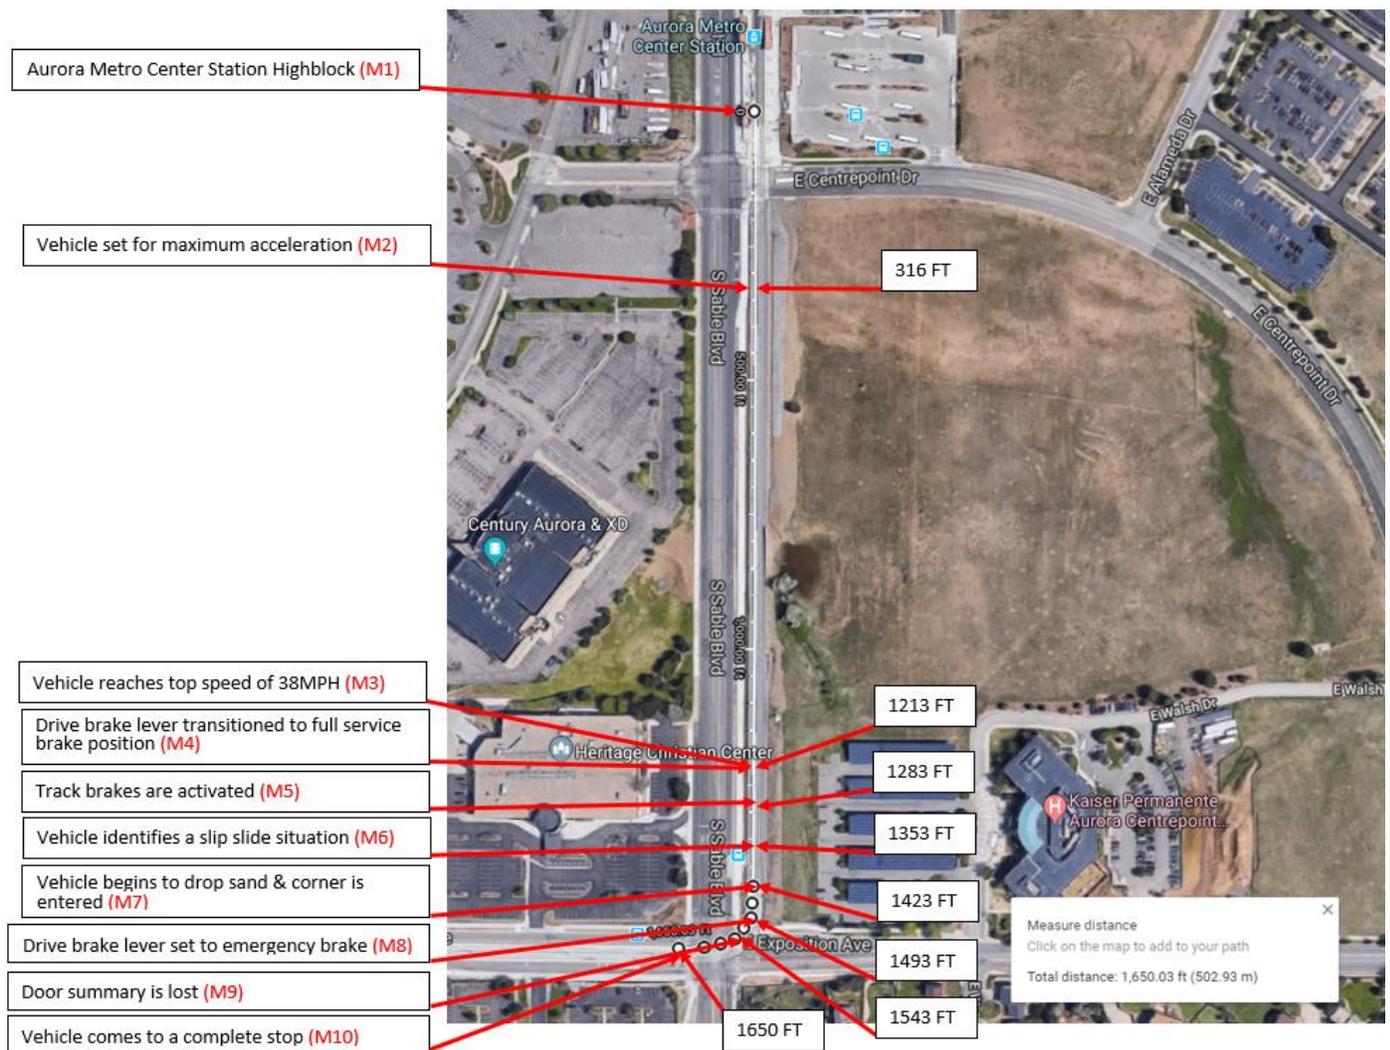
The computer generated records provided by APD and RTD indicate that Hartzel initially applied moderate acceleration upon leaving the Metro station, causing the train to reach a speed of 17 mph at approximately 316 feet after leaving the Metro station. Hartzel then applied full acceleration, causing the train to accelerate to 38.5 MPH within approximately 19 seconds, reaching that speed at 1,213 feet south of the Metro station. The speed limit for trains on that stretch of track is 35 mph, and a 35 mph speed limit sign is posted just south of the Metro station between the tracks, visible to southbound train operators. Within less than a second of reaching the speed of 38.5 mph, Hartzel applied full brakes with the throttle control, resulting in a rapid deceleration of the train. Within a second of the full brakes being applied, a second braking system known as the "track brakes" was also applied, resulting in further rapid deceleration. This second set of brakes is operated through a so-called "deadman" switch, whereby Hartzel removed his foot from a switch on the floor, causing the "track brakes" to automatically be engaged. Within a

second of that occurring, the train's sensors detected that the wheels were sliding on the track, and deployed sand to the tracks from containers on the train's undercarriage, in order to supply additional traction. Within two seconds of that occurring, Hartzel pulled the throttle mechanism further back, past the "full brake" position, to "emergency braking". By the time the emergency brake was applied, the train had arrived at the 90-degree eastbound turn at Exposition Avenue, and was still traveling 30 mph. The speed limit for all 90-degree turns on RTD tracks of this type is 10 mph. A 10 mph speed limit sign is posted, visible to southbound train operators, on a post approximately 50 feet before the start of the turn. Thus, the train was traveling at approximately triple the posted speed when it entered the curve. Because of the train's excessive speed, it was unable to normally negotiate the 90-degree turn, and instead the right, inside train wheels derailed from the track, tilting the train significantly to its left, outside side. The below diagram illustrates the location of the train at the point each of the above actions occurred:

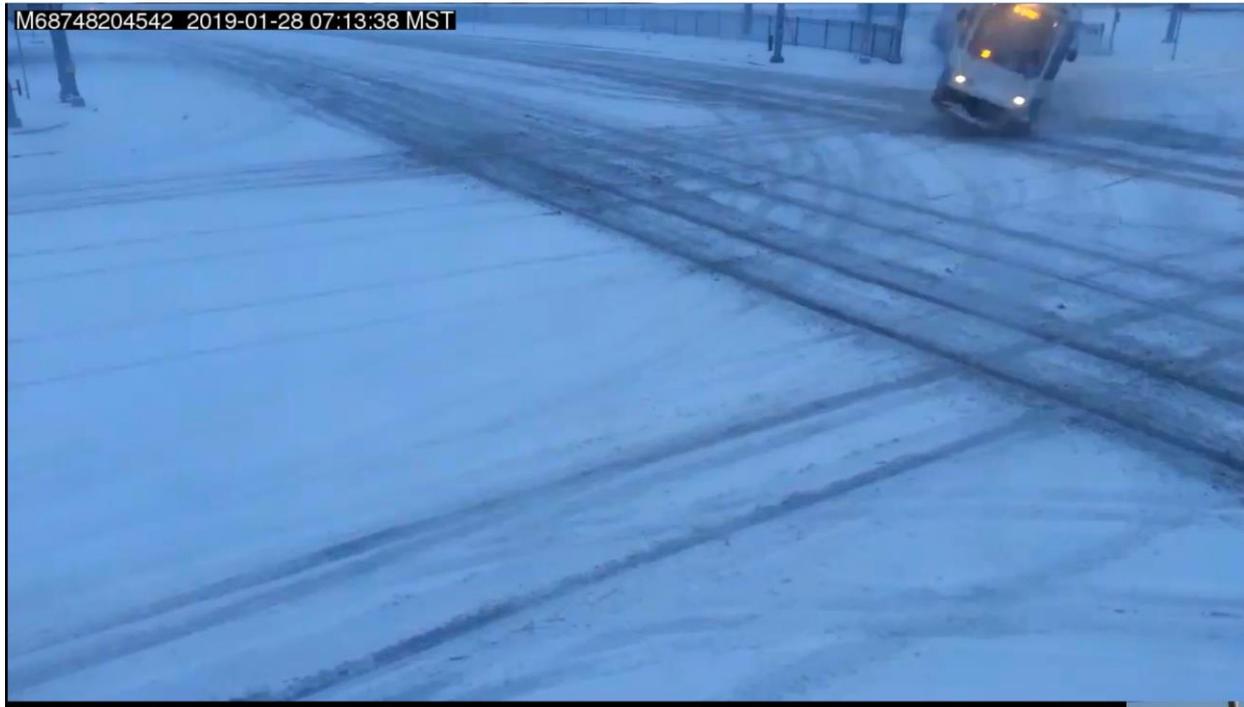
The wheels on RTD trains have a flange that is designed to prevent the wheels from detaching from the track in most situations. However, given the extreme angle at which the train tilted, the flange was unable to keep the wheel on the track, and it instead lifted off of the track. The below still picture, taken from a traffic camera located at the corner of Exposition Ave and

looking to the northeast across Exposition towards Sable, captured the appearance of the train as it attempted to negotiate the curve:

The train ultimately did not turn over on its left side. This appears to be due to the train cab striking a pole shortly after the right wheels had derailed and the train had begun to lean to the left, prior to the above image being captured. The impact with the pole was sufficient to knock the train back towards its center and avoid a complete derailment.

The detachment of the inside tracks coupled, with the southeasterly momentum of the train as it entered the curve, caused the right (inside) side of the train to lift substantially. This same action also caused the left (outward) side of the train to tilt downward towards the road surface. This substantial downward tilt caused portions of the train's underside surfaces, known as stepwells, to make forceful contact with the road surface. The stepwells are the portions of the train's bottom surface above which the doors are seated, and that passengers use as steps to enter and exit the train. These stepwells are lower than the other parts of the train's bottom surface, and thus were the first portions of the underside to make contact with the road surface. The force of the stepwells striking the road surface caused the train's frame to deform upward in the vicinity of the stepwell. Because the doors are seated in that same location, this upward deformation caused the door frames themselves to deform. The doors on RTD trains are secured by multiple roller devices that are designed to withstand 600 pounds of outward pressure. However, the amount of pressure generated by the stepwells striking the road, coupled with that pressure being channeled in an upward direction, caused those roller devices to fail and the doors to open.

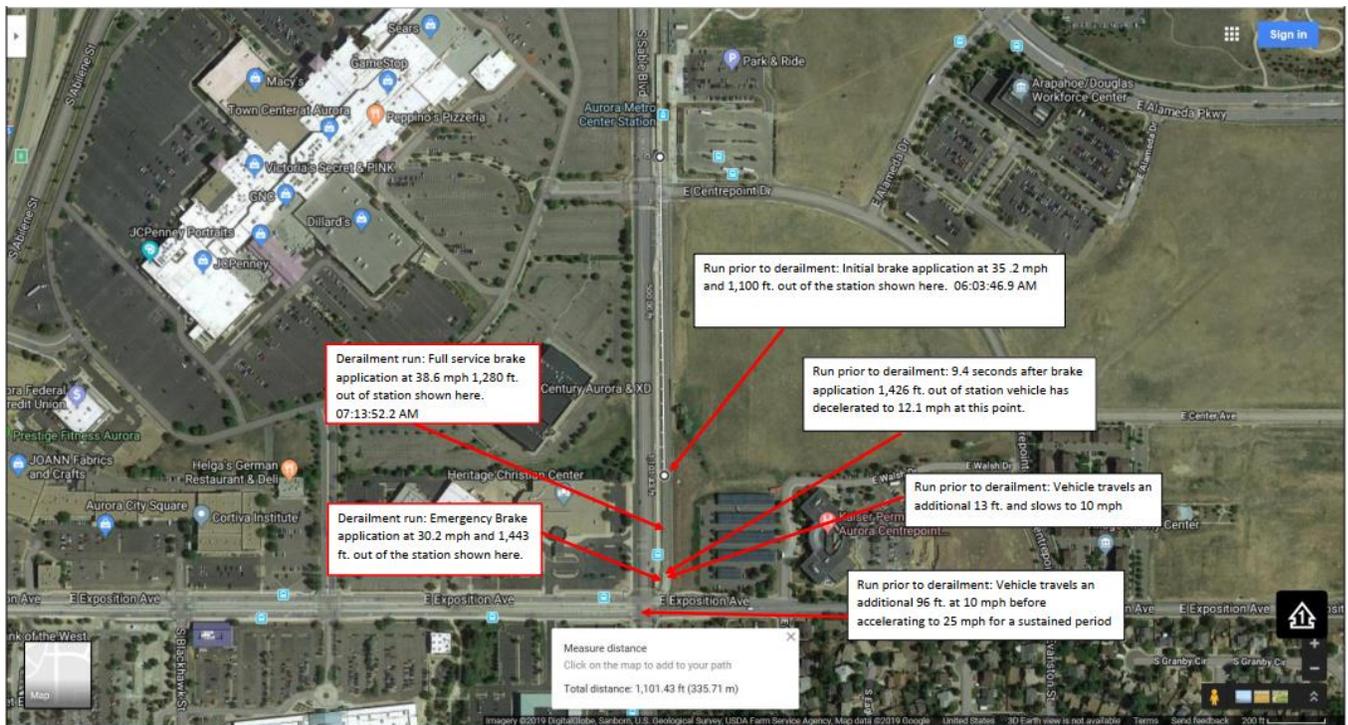
Hartzel had operated the same train through the same area a little over one hour earlier, at 6:03 a.m. on January 28. That run was completed in a safe and normal manner. Computer records of that earlier run, showing speeds and operator actions, were also supplied to our office. The below map provides information about how Hartzel’s actions differed between the first, safe run and the derailment run, and how Hartzel’s actions in the second run caused the derailment. On the right side of the map are references to speeds and driver actions taken in the earlier, safe run. On the left side are references to actions and speeds taken in the derailment run. The Aurora Metro Center Station is at the top center of the map, with the location where the derailment occurred being at the bottom center:

Thus, as reflected in this map, on the derailment run Hartzel accelerated the train to a higher top speed while southbound along Sable than in the safe run, 38.5 mph versus 35.2 mph. Hartzel also began to decelerate later on the derailment run than on the safe run, at 1,280 feet from the Metro station versus at 1,110 feet on the safe run. It is apparent that the combination of a higher speed and a later initiation of braking resulted in the train not having sufficient time to decelerate to a safe speed before entering the turn at Exposition, thus causing the derailment.

From all of the available evidence, it appears this incident was caused by Mr. Hartzel accelerating the train to a higher than normal speed after leaving the Metro station, and subsequently not reducing the train's speed sufficiently prior to the curve. From the available evidence, it appears that once the train entered the curve at a high rate of speed, a derailment was essentially inevitable.
